Manhole Inspection Summary

Manhole # S39W1_020MH

Insp Date: **11/19/07 8:45 AM**

Location Address: **400 Maude Ave**

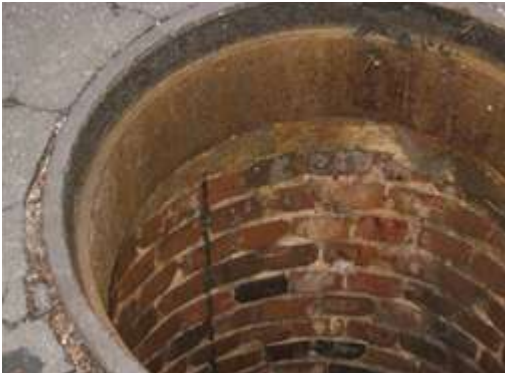
Defect 2

Condition: ☐ Sound ☒ **Cracked** ☐ Root Intrusion ☐ Loose Brick ☐ Deteriorated

Infiltration: ☐ None ☐ Joint ☒ **Cracks** ☐ Mortar ☐ Roots ☐ Wall

Chimney/Frame

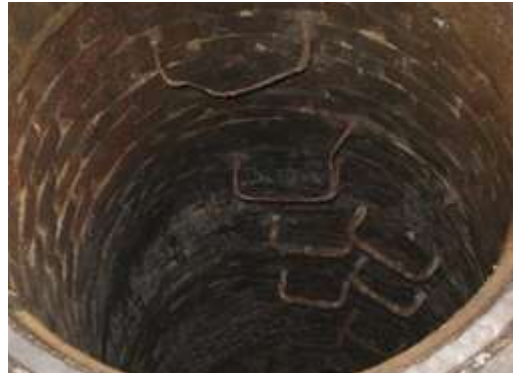
Defect 1

Count: **7** Missing: **2** ☒ **Corroded**

Corroded Steps

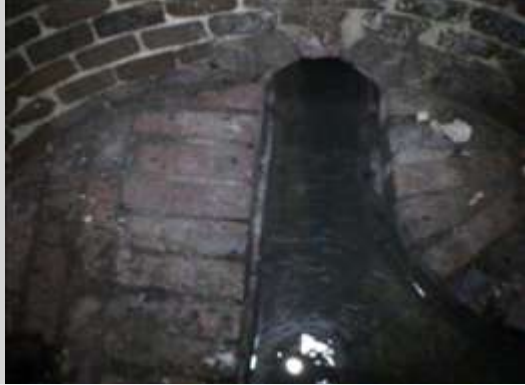
12 O'Clock Outflow

8 in. Circular Gravity Sewer
Pipe Out @ 12 O'Clock

Pipe Height: **9.6** (in.) Rod and Bar (Angled)
Pipe Material: **Clay** ☐ Pipe Lined
Invert Depth: **15.29** (ft.) Flow Characteristics: **Slow**
Deposits: ☒ None ☐ Mud ☐ Sludge ☐ Debris ☐ Grease
Silt Depth: (in.) Deposits Extent:
Infiltration: **None** Pipe Seal Cond: **Sound**

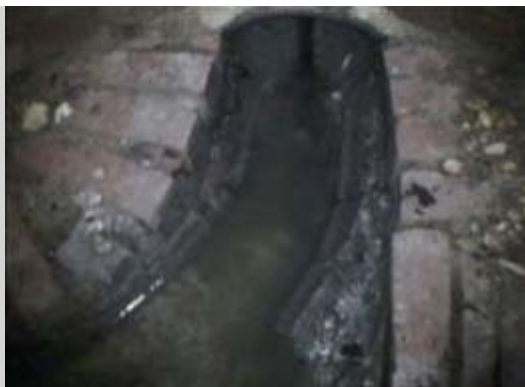
3 O'Clock Inflow

8 in. Circular Gravity Sewer
Pipe In @ 3 O'Clock

Pipe Height: **9.6** (in.) Rod and Bar (Angled)
Pipe Material: **Clay** ☐ Pipe Lined
Invert Depth: **15.21** (ft.) Flow Characteristics: **Slow**
Deposits: ☒ None ☐ Mud ☐ Sludge ☐ Debris ☐ Grease
Silt Depth: (in.) Deposits Extent:
Infiltration: **None** Pipe Seal Cond: **Sound**

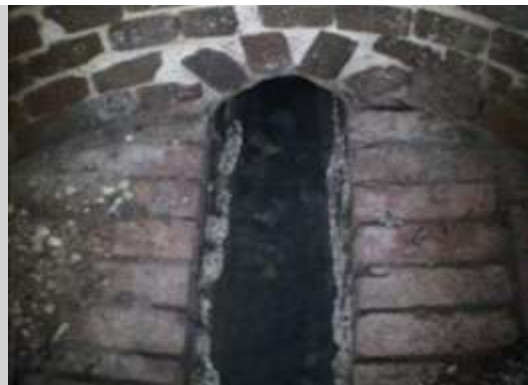
6 O'Clock Inflow

8 in. Circular Gravity Sewer

Pipe In @ 6 O'Clock

Pipe Height: **9.6** (in.) Rod and Bar (Angled)

Infiltration: **None** Pipe Seal Cond: **Sound**
